## 10.0 BEST MANAGEMENT PRACTICES (BMPs)

### 10.3 BMP Examples

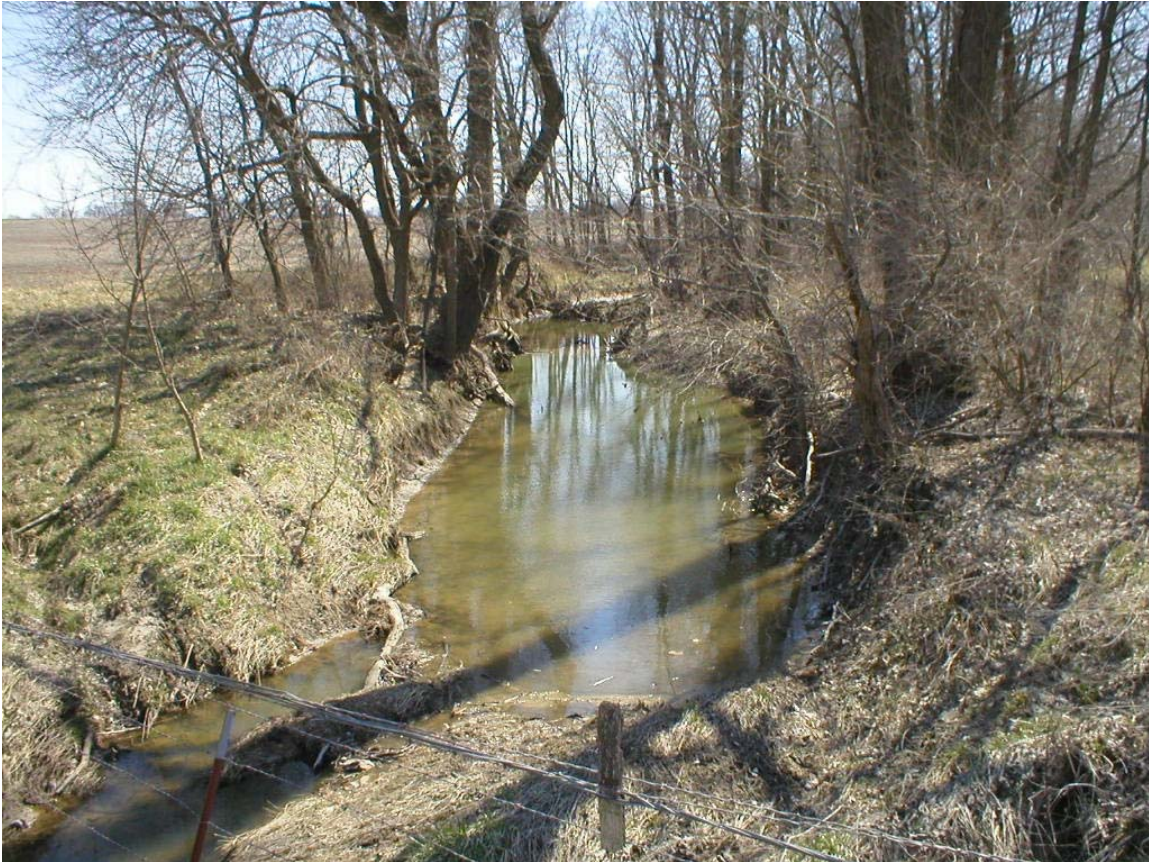
**Photo 10.3-i** Buffer Agricultural Areas from Channels

Photo 10.3-i shows an area with row crops very close to the side of the channel (left side of channel in photo). If a buffer strip were added to these areas, either with woodland or prairie vegetation, it would improve water quality by decreasing overland sediment and nutrient transport, provide for increased biodiversity and wildlife habitat, increase infiltration potential, and provide for some degree of flood protection.

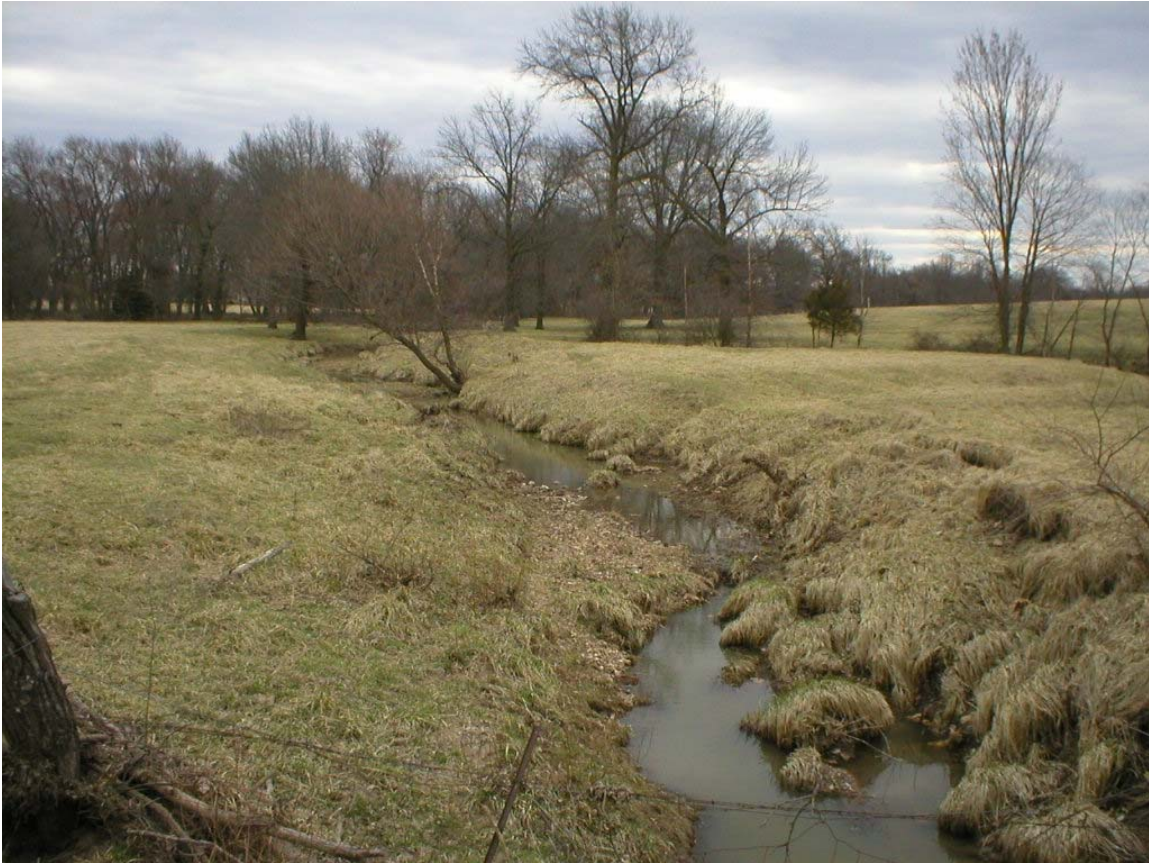
**Photo 10.3-ii** Buffer Pasture Areas from Channels

Photo 10.3-ii shows an area with pastured regions extending into the channel. If a buffer strip were added to these areas, either with woodland or prairie vegetation, it would improve water quality by decreasing overland sediment and nutrient transport, provide for increased biodiversity and wildlife habitat, increase infiltration potential, and provide for some degree of flood protection.

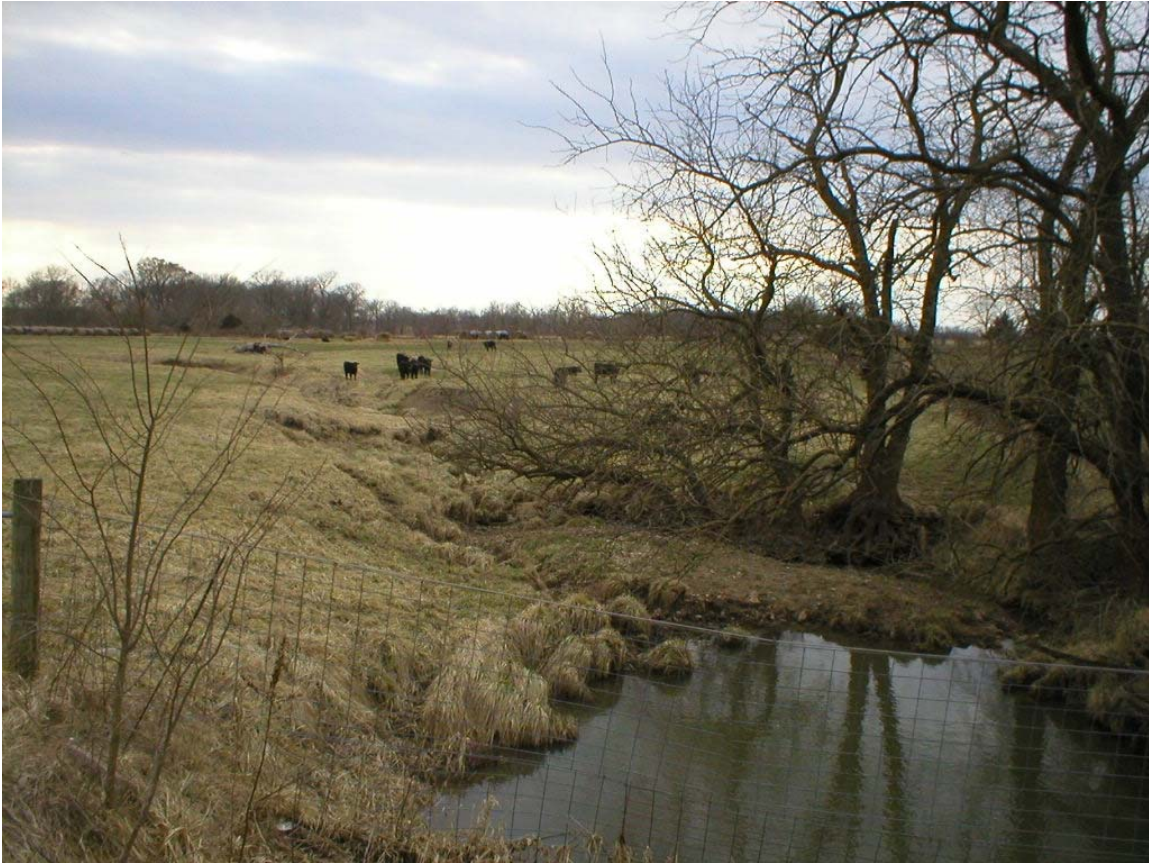
**Photo 10.3-iii** Exclusion of Livestock from Riparian Corridors

Photo 10.3-iii is an example of the cattle grazing practices observed during site visits. To minimize nutrient loading and channel disturbance, livestock should be prevented from grazing or crossing channels wherever possible. This would improve water quality and aid in channel stability.

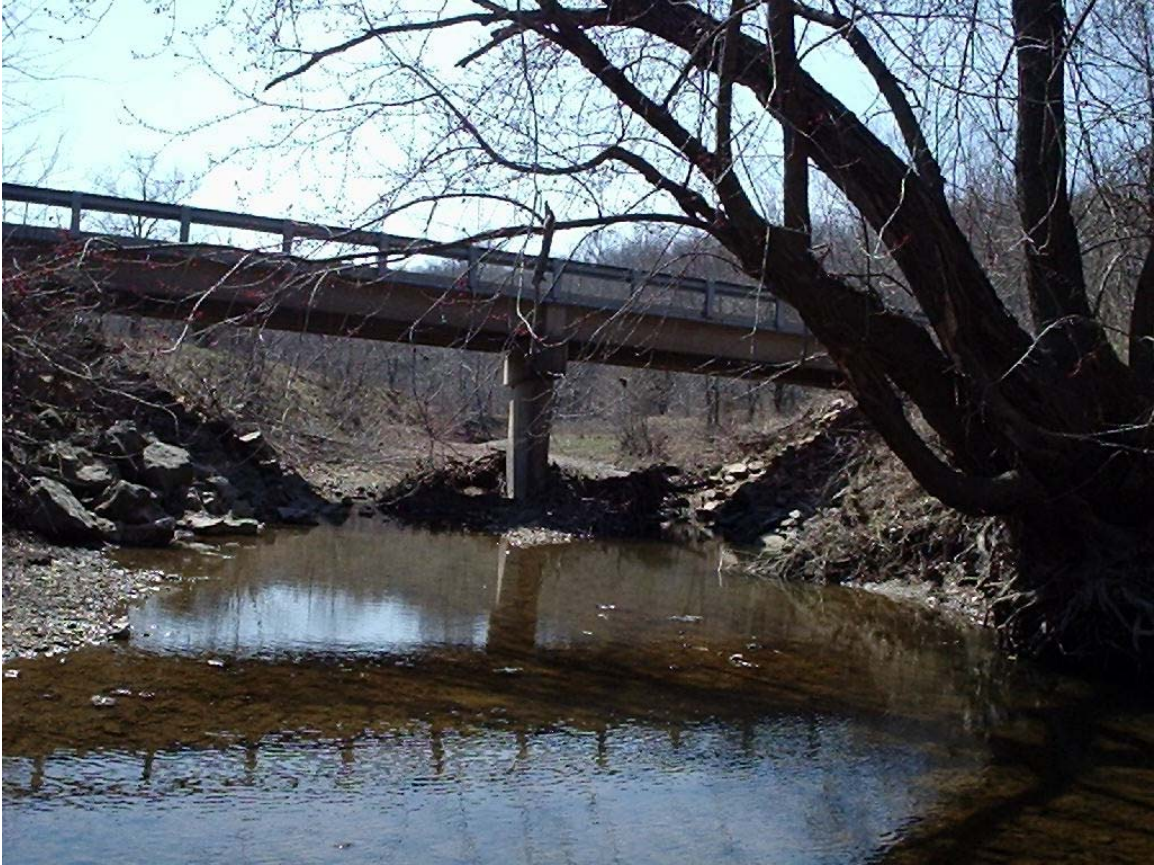
**Photo 10.3-iv** Channel Debris Removal

The accumulation of debris shown in Photo 10.3-iv can restrict channel conveyance capacity, which will ultimately increase water surface elevations, exacerbate flooding and cause streambank erosion and channel instability. These areas should be monitored and debris should be removed on a regular basis.

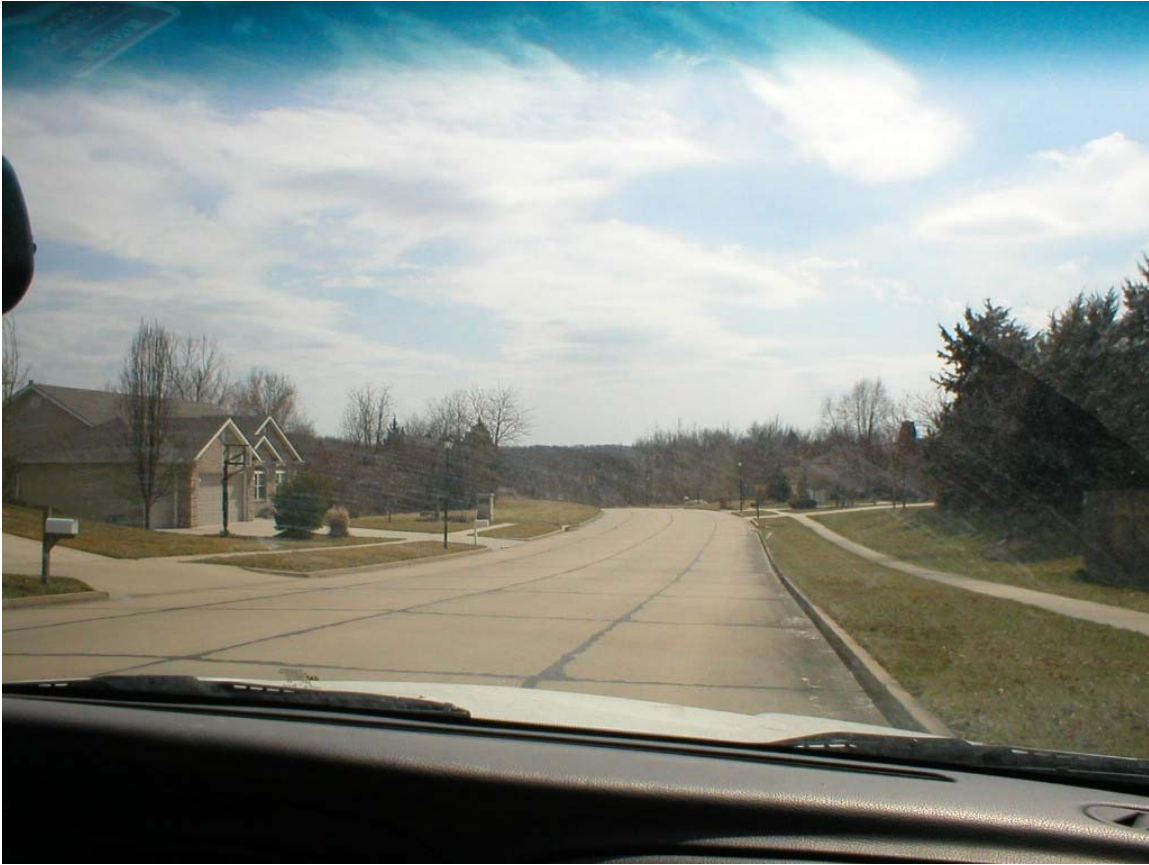
**Photo 10.3-v** Minimizing Road Widths in New Subdivisions

As new developments are constructed in the area, a potential requirement could be reducing the road widths. This would decrease impervious area, resulting in lower runoff volumes because of increased infiltration. In general, motorists also tend to slow down on narrow streets.

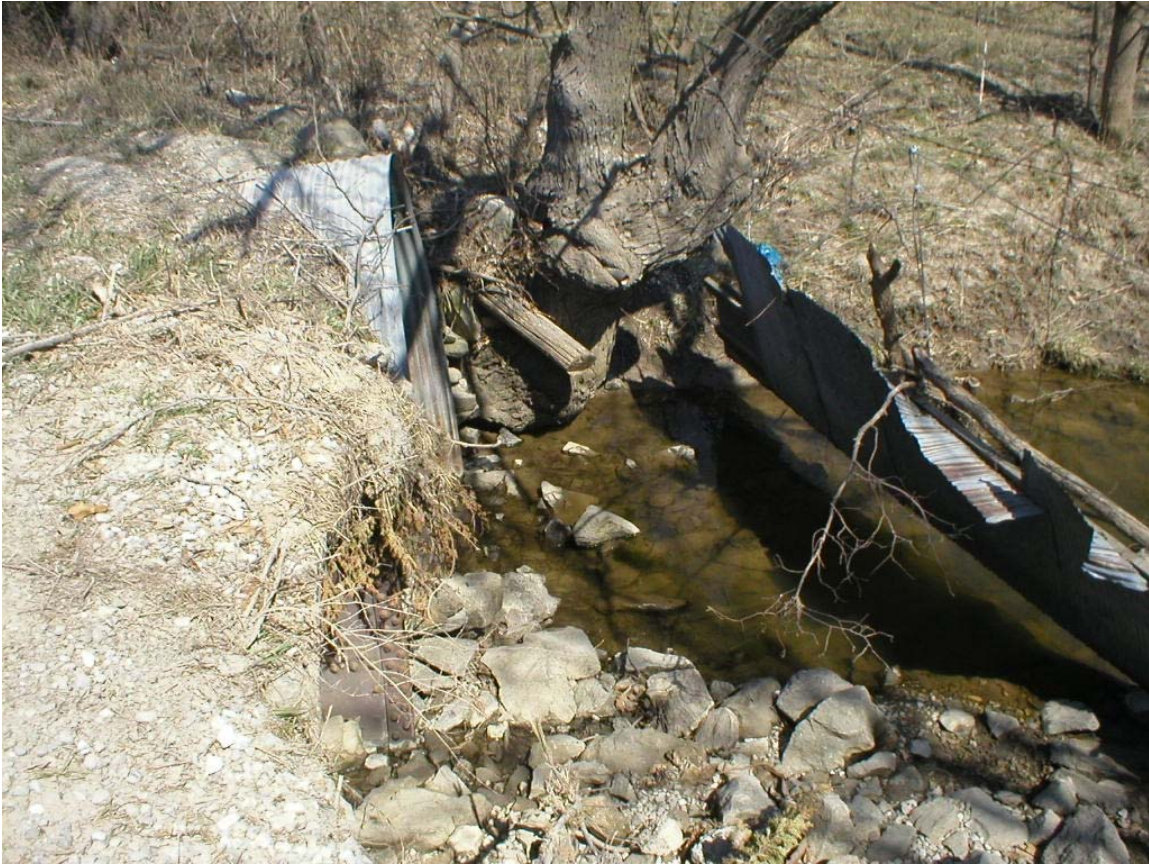
**Photo 10.3-vi** Remove Farm Fences Obstructing Channels

Several channels were observed with fencing directly across a channel, and as in Photo 10.3-vi, some of these fences were equipped with sheet metal to prevent animals from moving under the fences. As high discharges flow out of culverts into these areas, there is potential for erosion of the road embankment and channel banks as water diverts around the obstruction.

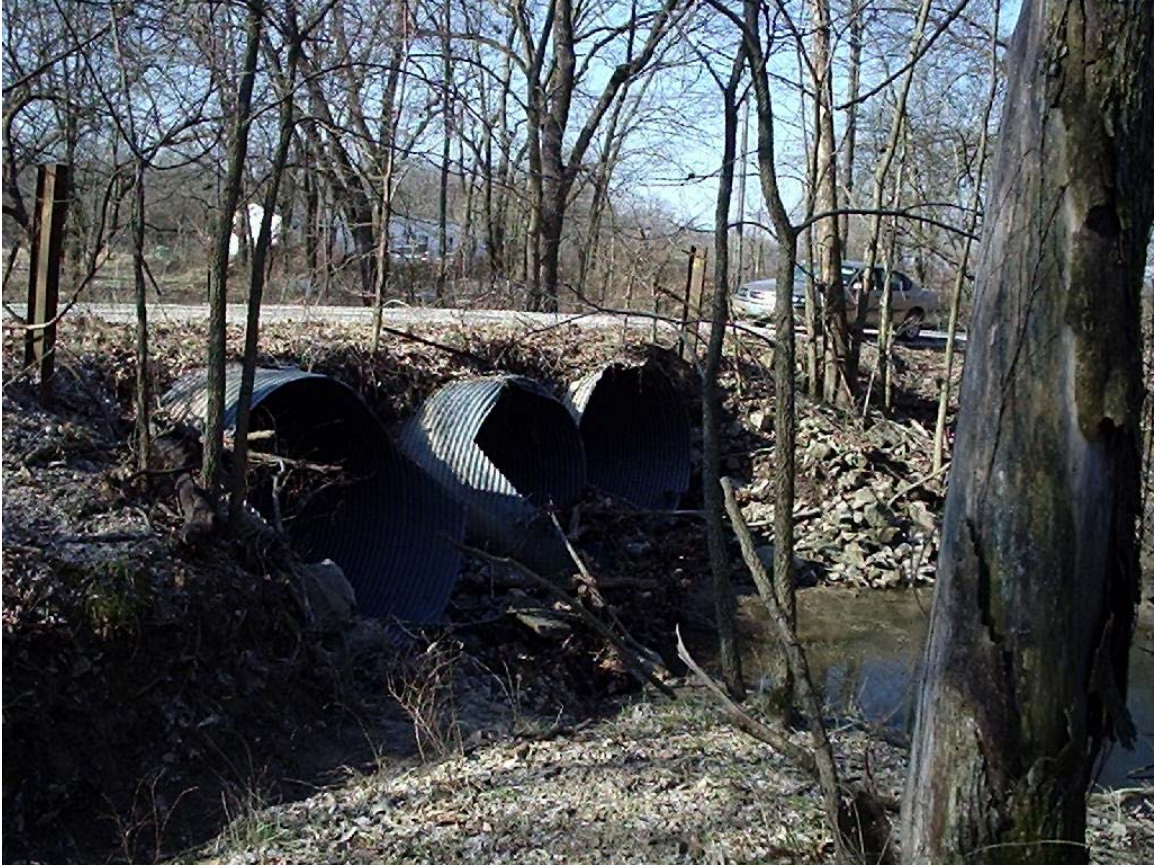
**Photo 10.3-vii** Reshape Culverts

As shown in Photo 10.3-vii, this culvert could be realigned to provide for more natural stream flows. A hanging culvert such as this will impede the passage of fish or amphibians and could also increase erosion potential during high flow events.

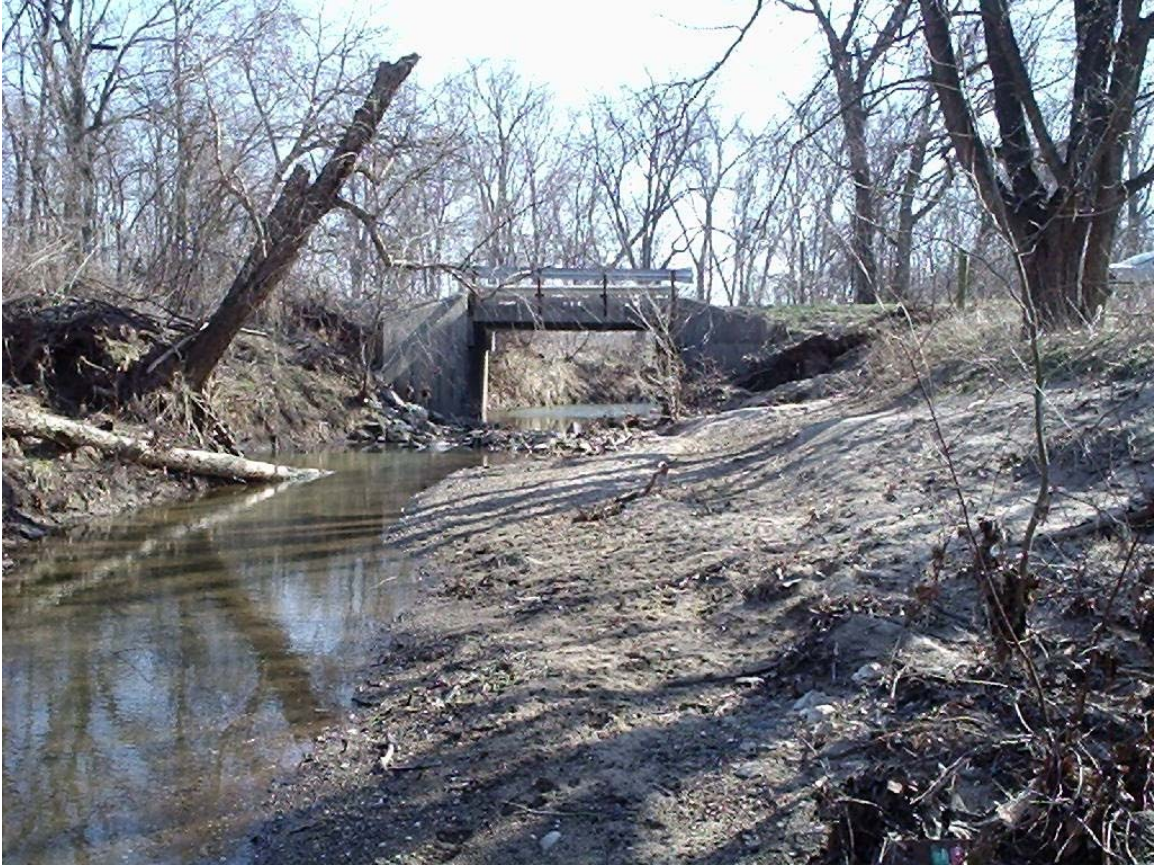
**Photo 10.3-viii** Resize Culverts

This example presents a problem related to that of Photo 10.3-vii where this culvert appears to be undersized, or the stream has possibly reshaped itself since installation. Based on the dimensions of the observed channel, it appears that at high flows the culvert will restrict flows to the point of overtopping the road. A wider span below this road crossing would alleviate this problem.
