APPENDIX 1:
Cross-section Photos and Cross-sections

Figure A1. Photo Location Map. The numbers on the following photos correspond to the location numbers identified in yellow on the above Index Map for the Bonne Femme Watershed.

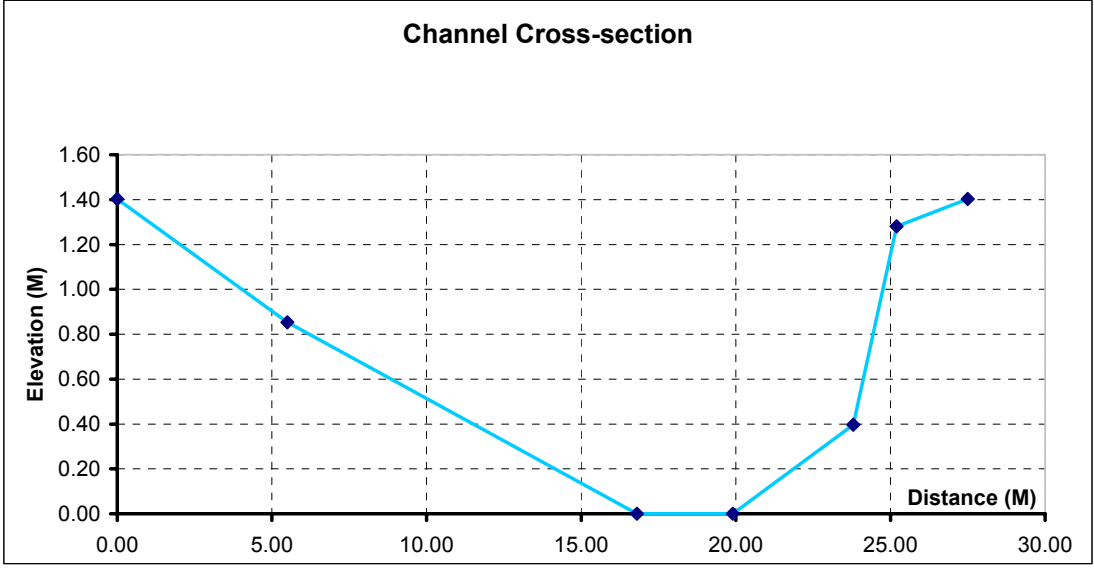
Figure A5. Cross-section: 4. Upper Bonne Femme Lower.

Station	Distance (m)	Rod (ft)	El. (M)	El. (ft)	Notes
HOI			5.40		
1	0.00		5.40	1.40	4.60 BF
2	5.50		7.20	0.85	2.80
3	16.80		10.00	0.00	0.00 THAL & EOW
4	19.90		10.00	0.00	0.00 EOW
5	23.80		8.70	0.40	1.30 TOE
6	25.20		5.80	1.28	4.20 TOP OF BANK
7	27.50		5.40	1.40	4.60

Bottom Width (ft)= 23.0
 Side Slope (xH:1V) = 8.7
 Manning's n = 0.055

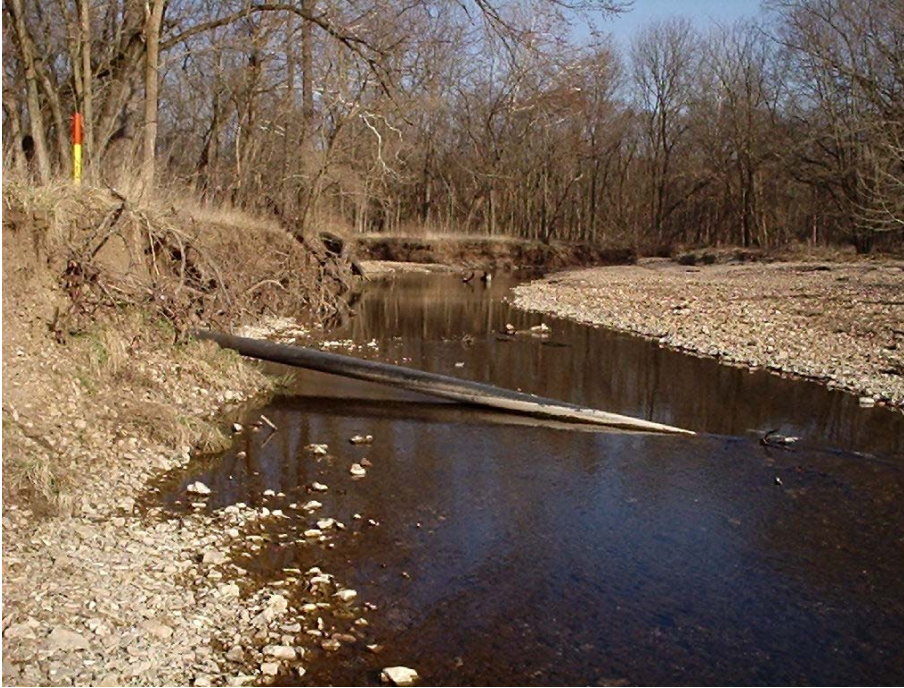
Photo 6C. Clear Creek. Exposed pipe.

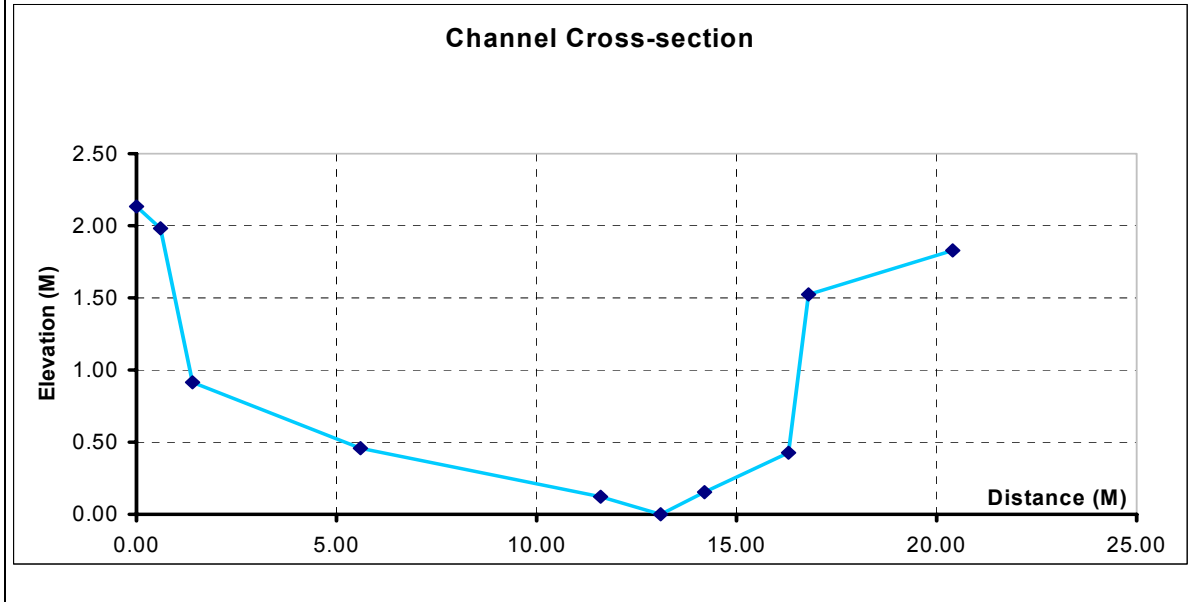
Figure A7. Cross-section: 6. Clear Creek.

Station	Distance (m)	Rod (ft)	El. (m)	El. (ft)	Notes
HOI			5.40		
1	0.00	3.00	2.13	7.00	
2	0.60	3.50	1.98	6.50	TOB
3	1.40	7.00	0.91	3.00	BF
4	5.60	8.50	0.46	1.50	
5	11.60	9.60	0.12	0.40	EOW
6	13.10	10.00	0.00	0.00	THAL
7	14.20	9.50	0.15	0.50	EOW
8	16.30	8.60	0.43	1.40	
9	16.80	5.00	1.52	5.00	TOB
10	20.40	4.00	1.83	6.00

Bottom Width (ft)= 8.5
 Side Slope (xH:1V) = 3.9
 Manning's n = 0.045

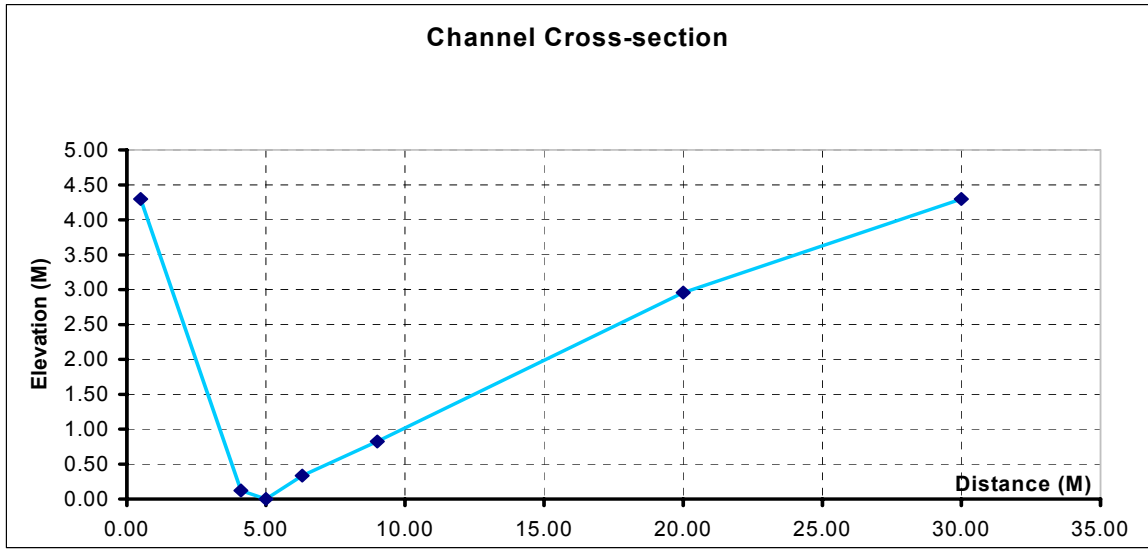
Figure A8. Cross-section: 7. Fox Hollow Branch.

Station	Distance (m)	Rod (ft)	El. (m)	El. (ft)	Notes
HOI					
1	0.50	0.00	4.30	14.10	TOB
2	4.10	13.70	0.12	0.40	EW
3	5.00	14.10	0.00	0.00	THAL
4	6.30	13.00	0.34	1.10	EW
5	9.00	11.40	0.82	2.70	
6	20.00	4.40	2.96	9.70	BF
7	30.00	0.00	4.30	14.10

Bottom Width (ft)= 7.2
 Side Slope (xH:1V) = 3.4
 Manning's n = 0.050

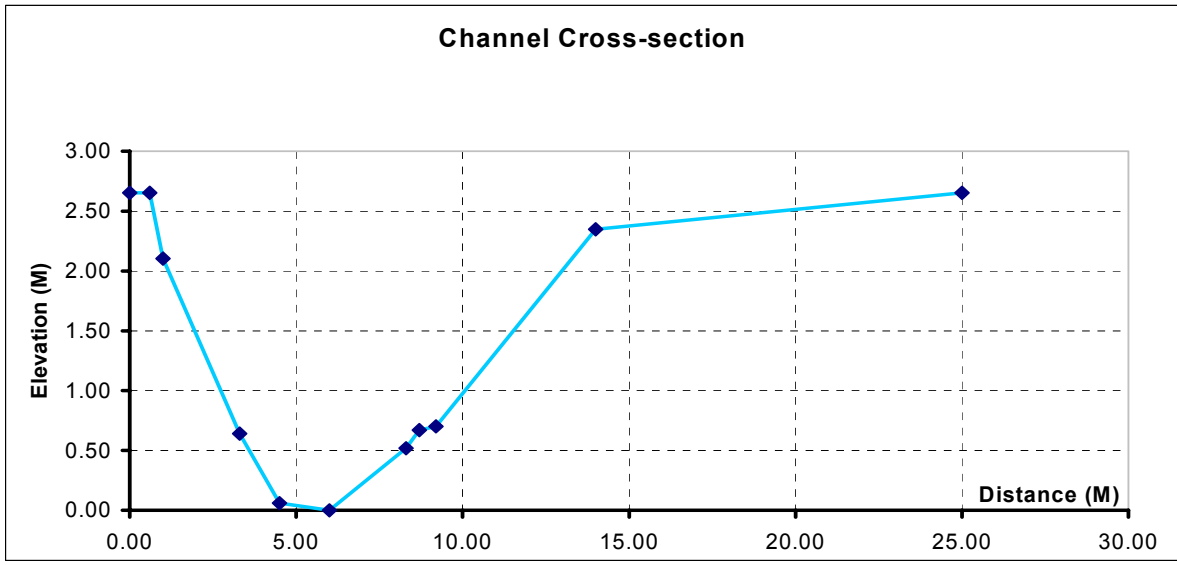
Figure A9. Cross-section: 8. Gans North.

Station	Distance (m)	Rod (ft)	El. (ft)	Notes
HOI				
1	0.00	0.00	2.65	8.7
2	0.60	0.00	2.65	8.7 TOB
3	1.00	1.80	2.10	6.9
12	3.30	6.60	0.64	2.1 BF
4	4.50	8.50	0.06	0.2 EOW
5	6.00	8.70	0.00	0.0 THAL
6	8.30	7.00	0.52	1.7 EOW
7	8.70	6.50	0.67	2.2
13	9.20	6.40	0.70	2.3 BF
8	14.00	1.00	2.35	7.7
9	25.00	0.00	2.65	8.7 TOB
10				
11

Bottom Width (ft)= 12.5
 Side Slope (xH:1V) = 4.9
 Manning's n = 0.040

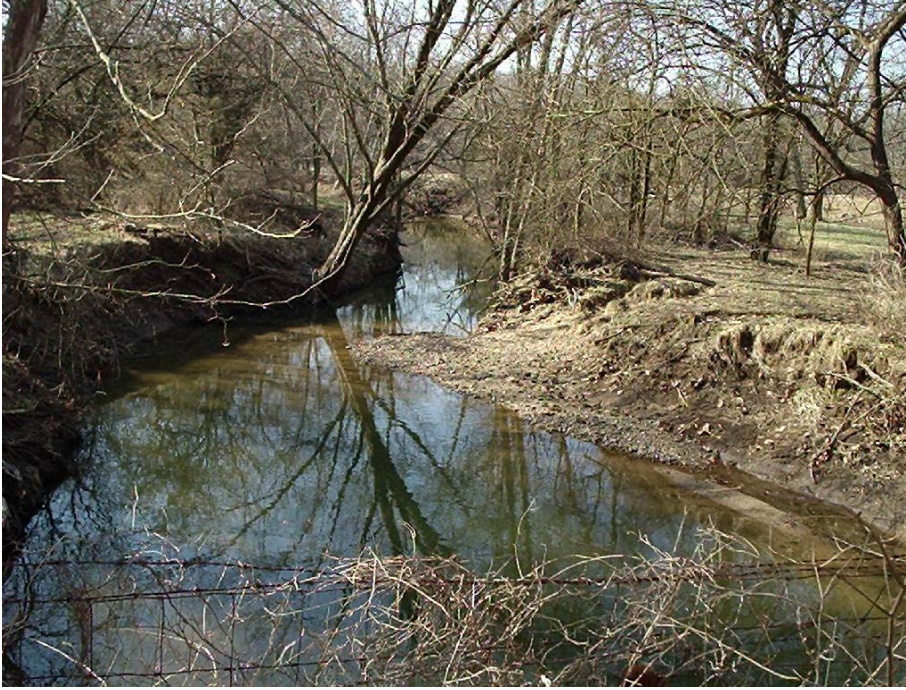
Photo 10B. Gans South. Looking downstream at culvert.
